STABILIZATION OF LOWRY RUINS

ADRIAN S. WHITE
AND
DAVID A. BRETERNITZ

Mesa Verde Research Center
University of Colorado
Boulder, Colorado

March 1976

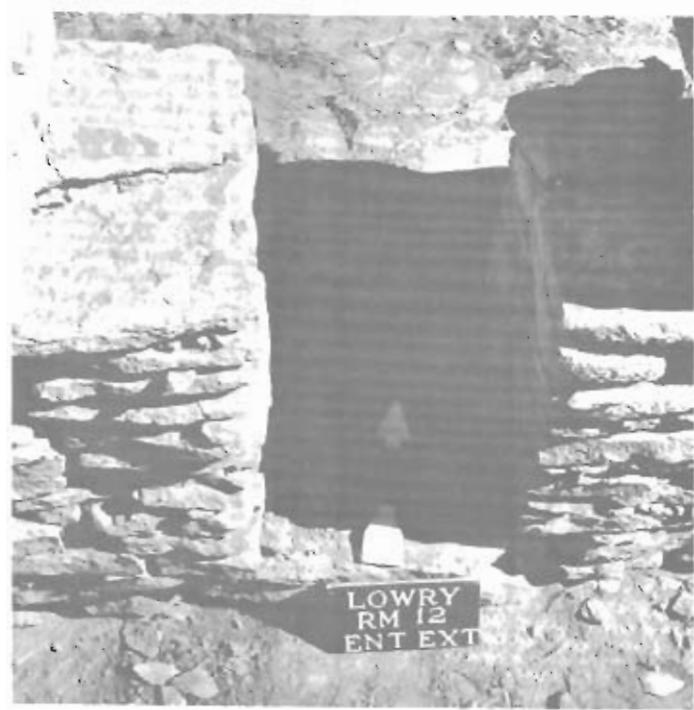
Figure 46. Room 12, south exterior entrance. a, large joints resulted from erosion of mortar; b, joints were grouted with cement.

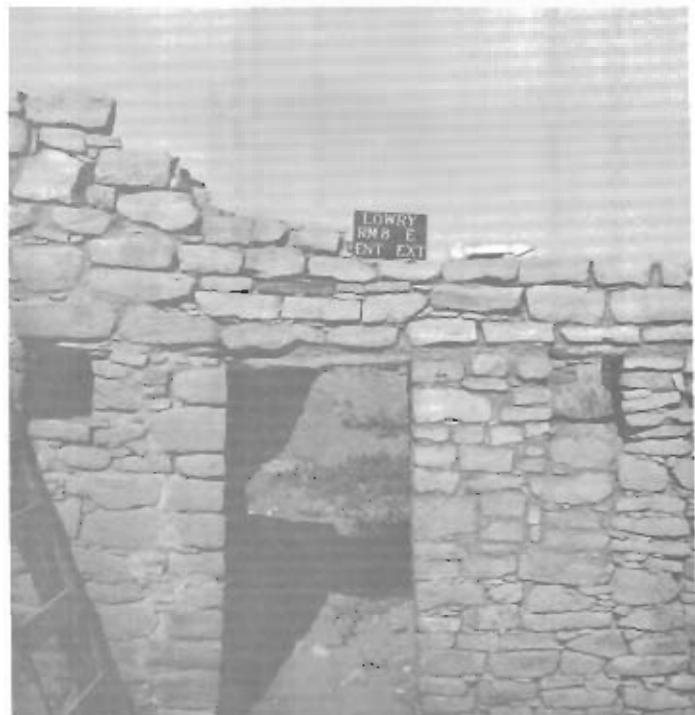
Figure 48. Room 8, east exterior entrance. All large joints of the interior and exterior wall were grouted. No photo was taken before stabilization.

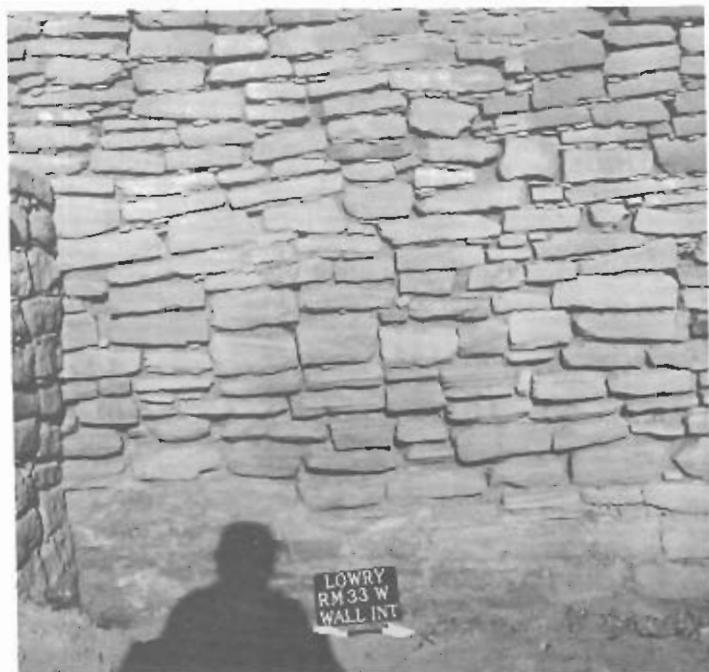
a

Figure 49. Room 33, north end of west interior wall. a, damage was confined to mortar crumbling from joints; excavation below ground surface showed no undermining of wall; b, soil mortar and spalls were replaced in the lower portion of the wall.

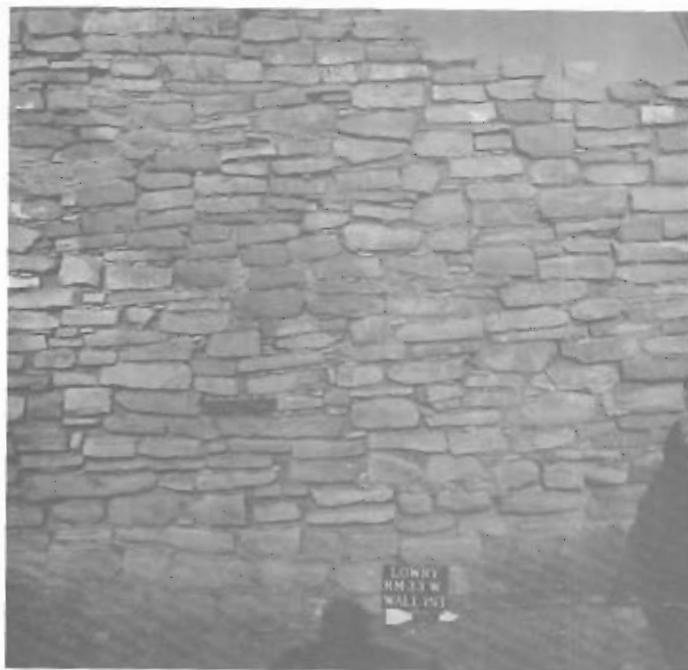
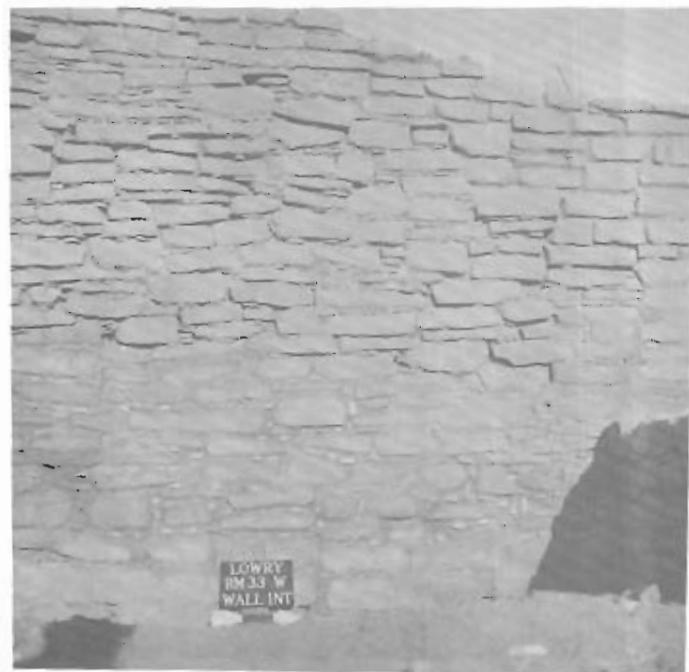
Figure 49. Room 33, south end of the west interior wall. c, damage was confined to mortar crumbling from joints; excavation below ground surface showed no undermining of wall; b, soil mortar and spalls were replaced in the lower portion of the wall.

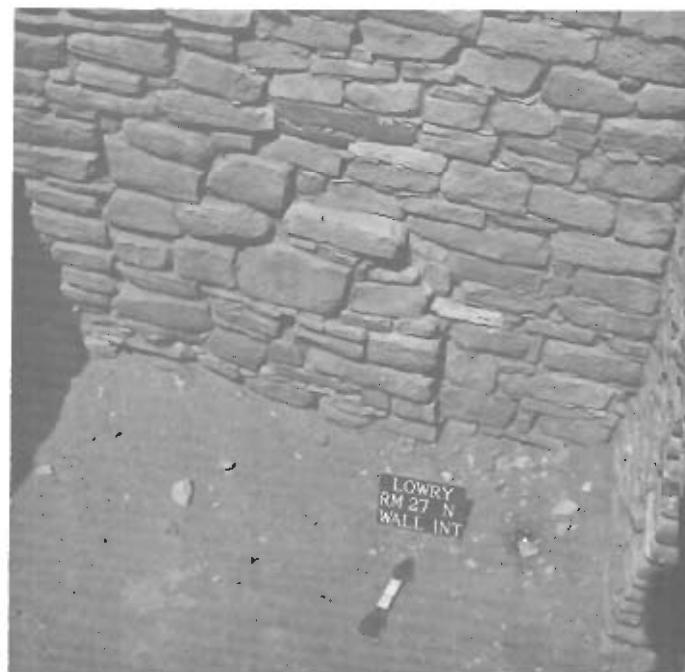
Figure 52. Room 27, north interior wall. a, several stones were missing and the mortar was crumbling beneath cement cap; b, stones were reset and the joints were grouted.

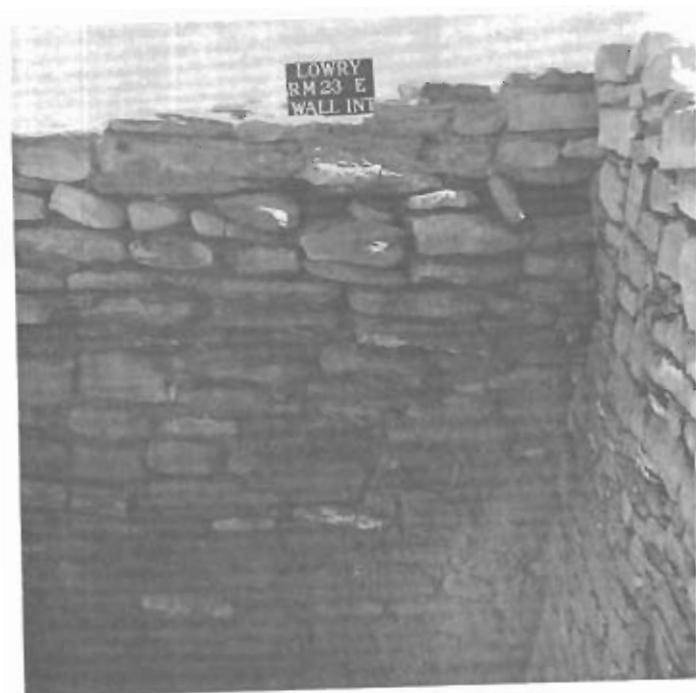
Figure 53. Room 23, east interior wall. a, masonry immediately beneath the cap was eroding; b, view after stabilization; photo board is mislabeled.

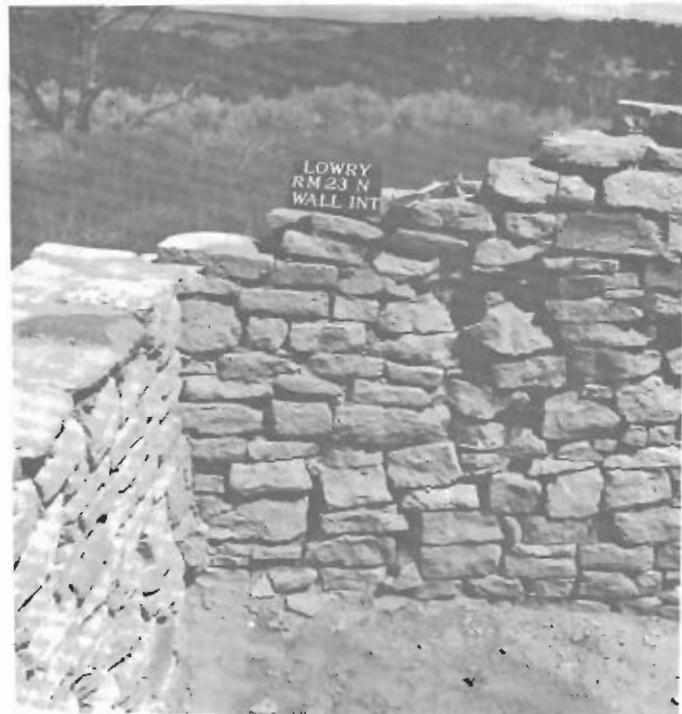
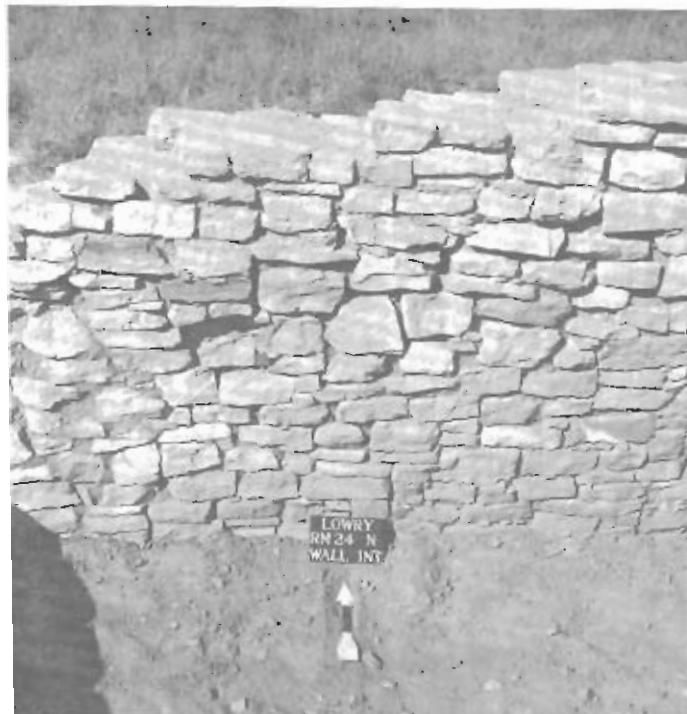
Figure 54. Room 23, north interior wall. a, several areas of the wall had large gaps resulting from crumbling mortar; b, after stabilization; Photo board is mislabeled.

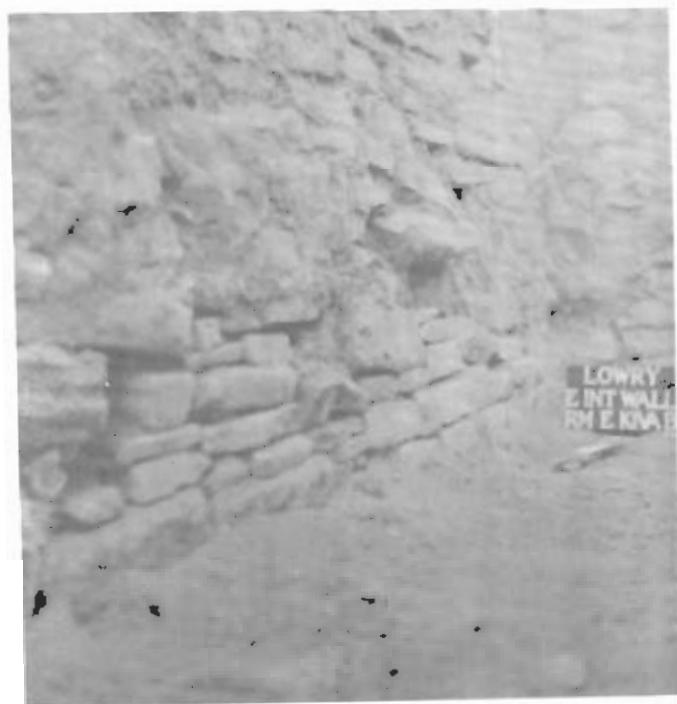
A cap of four courses was rebuilt in 1966. The area of erosion was below this cap where prehistoric masonry is still present. A portion of the original veneer was eroding from wall. The prehistoric soil mortar was soft and crumbling out in chunks. Along with veneer a new foundation had to be rebuilt for wall. Hence stones were loose at the base of wall.

Wall was being undermined by water beneath cement cap creating an unstable condition for entire wall.

Figure 55. Space east of Kiva B (unnumbered), east interior wall.
a, wall was undermined in large area; b, missing and loosened stones
were reset.

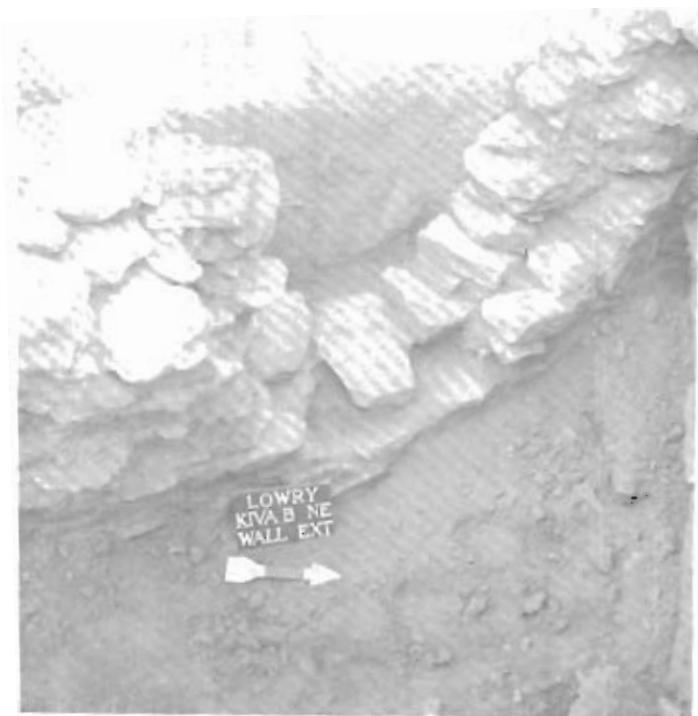
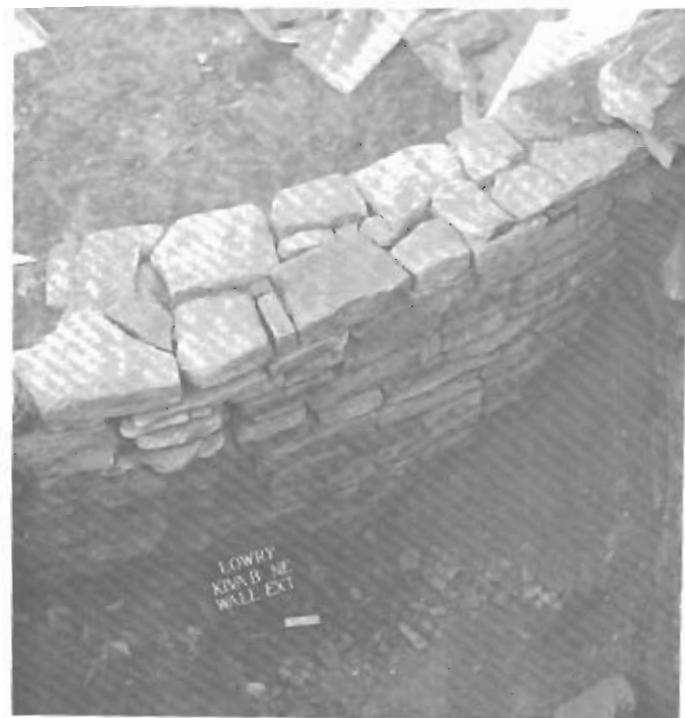
The wall contained no previous stabilization therefore entire wall was prehistoric.
 The wall was unstable with loose building stones and crumbling mortar from top course to 6-7 courses beneath. The entire thickness of wall had to be rebuilt.

Figure 56. Kiva B, northeast wall. a, stones were loosened throughout the thickness of the wall; b, wall was rebuilt to an even level to provide a foundation for roof.

The entire thickness of wall was taken down 6-7 courses. All loose stones and crumbling of loose mortar was taken out. Building stones were reset with a mixture of Portland Type I and II cement and Shiprock sand. All cemented joints were pointed with a soil mortar mixture of four parts soil to one part sand.

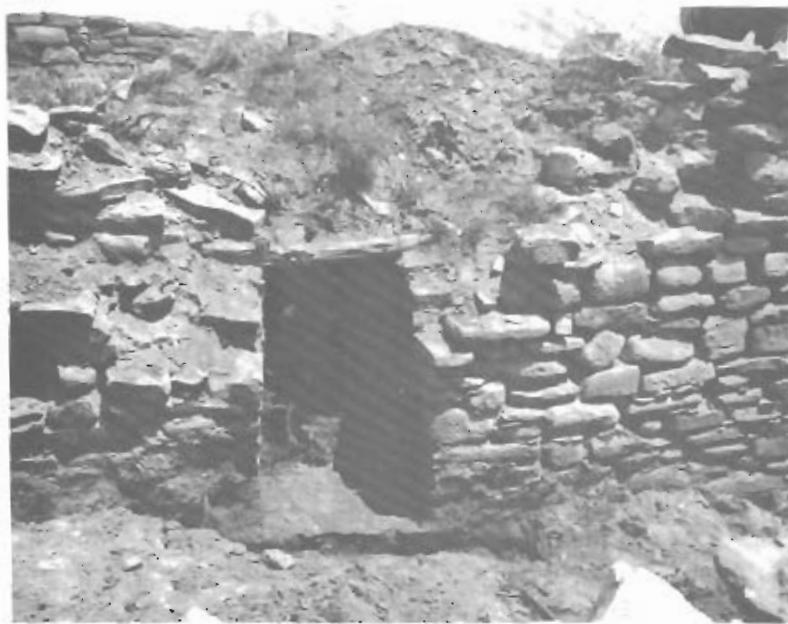
This wall was stabilized in 1967 but the wall settled causing the entrance to crack. Another cause for cracking was water seepage from associated Room 15 to the east which has a higher ground surface than Room 21. A hole possibly caused by a rodent was evident through entrance up to ground surface of Room 15.

Figure 58. Room 21, east interior entrance. a, before stabilization in 1966; b, rodent hole on exterior side that probably caused damage to the interior side.

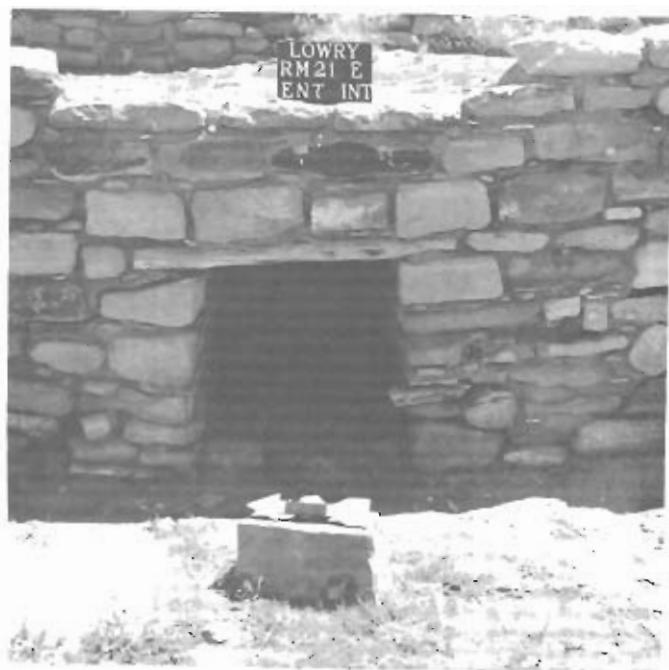
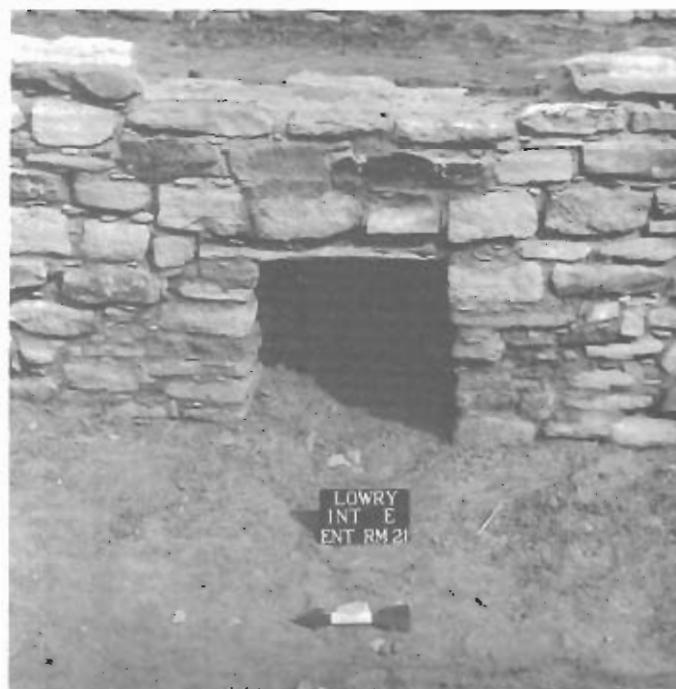
Only a small portion of prehistoric masonry remained in the entrance. This with several courses of stone to the north and south of doorway just above ground surface level. In this case the stones were loose in areas still containing prehistoric mortar.

Figure 58. Room 21, east interior entrance. c, a large crack extended from the lintel to ground surface and stones were loose to either side of the entrance; d, after stabilization.

All loose stones were removed and prehistoric soil mortar and cement was chiseled out of wall. Building stones were reset with a mixture of Portland Type I and II cement and Shiprock sand. All newly cemented joints were pointed with a 1:1:1 mortar mixture of 3 parts soil to 1 part sand.

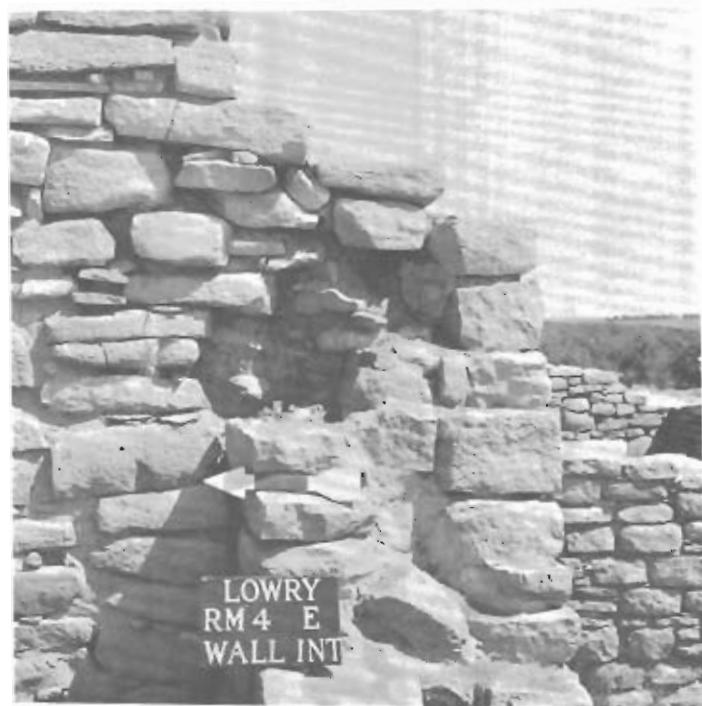
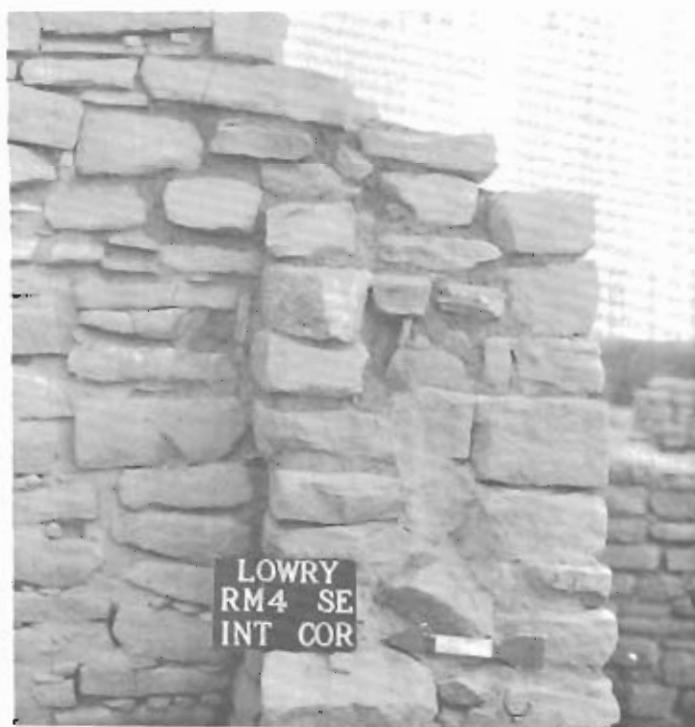
Orientalation, plan and type (situation, evidence of additional stories, period of construction relative to surrounding rooms, evidence of burning, etc.)
Several building stones had slipped from wall leaving gaps and the inner core of wall open to erosion.

Figure 59. Room 4, southeast interior corner. a, several stones slipped from wall leaving a large gap; b, stones were reset.

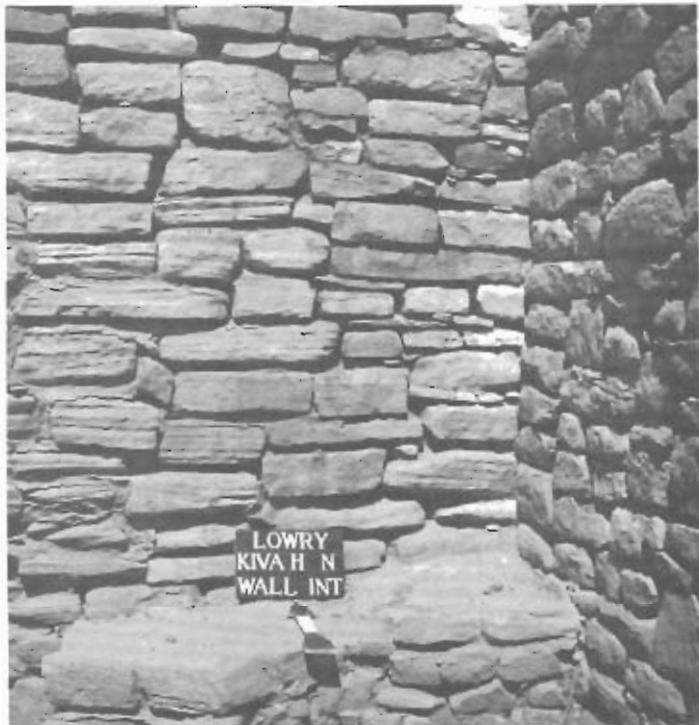
RUIN Lony Ruin
 The north wall of Kiva H has been capped. The area beneath the two course cement cap still contains prehistoric masonry. In most areas of this wall large joints are obvious between building stones where the prehistoric mortar has washed out. There was only one area where stones were missing and this was the area of cement patch.

Figure 61. Kiva H, north interior wall. A small patch was made with soil mortar where two stones had slipped from the wall. No photo was taken before stabilization.

Several small building stones were reset in wall with a mixture of Portland Type I and II cement and Shiprock sand.

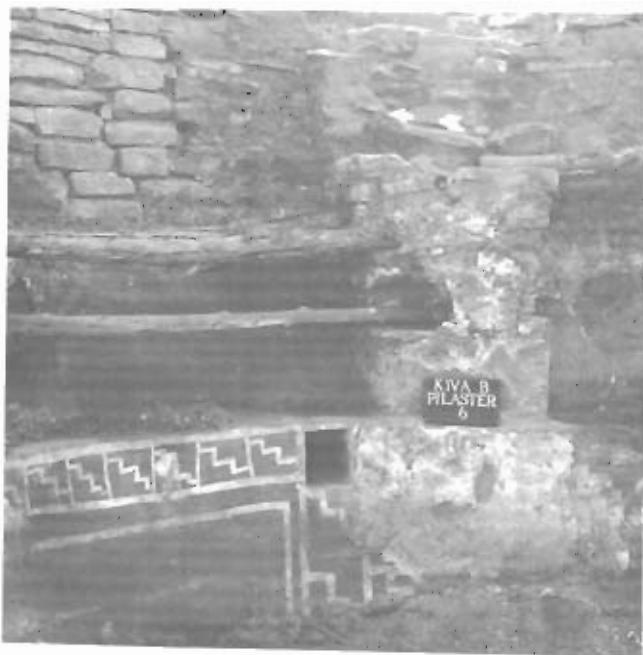
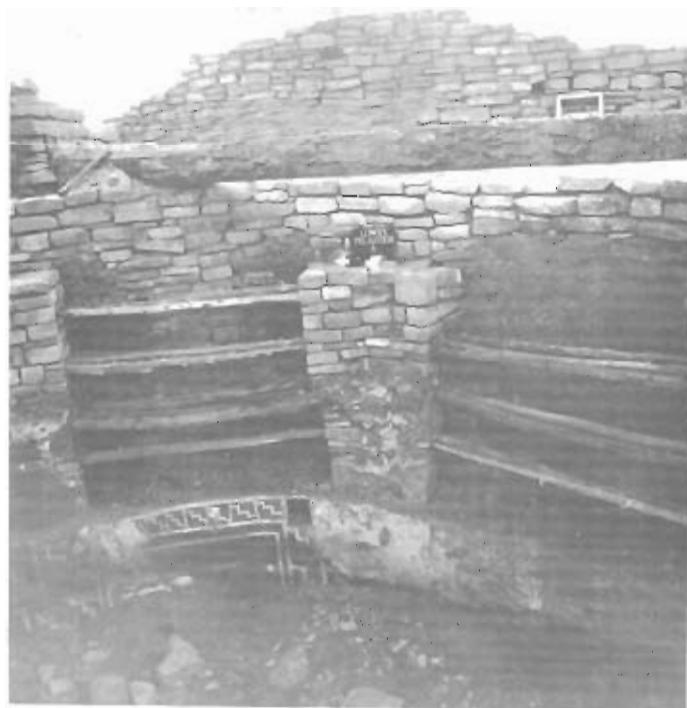
Ancient Masonry:
The masonry of plaster 6 was in poor shape to a depth of 7 courses from top
course. The stones were loose along with mortar.

Figure 62. Kiva B, pilaster 6. a, before stabilization showing the extent of damage; b, after stabilization.

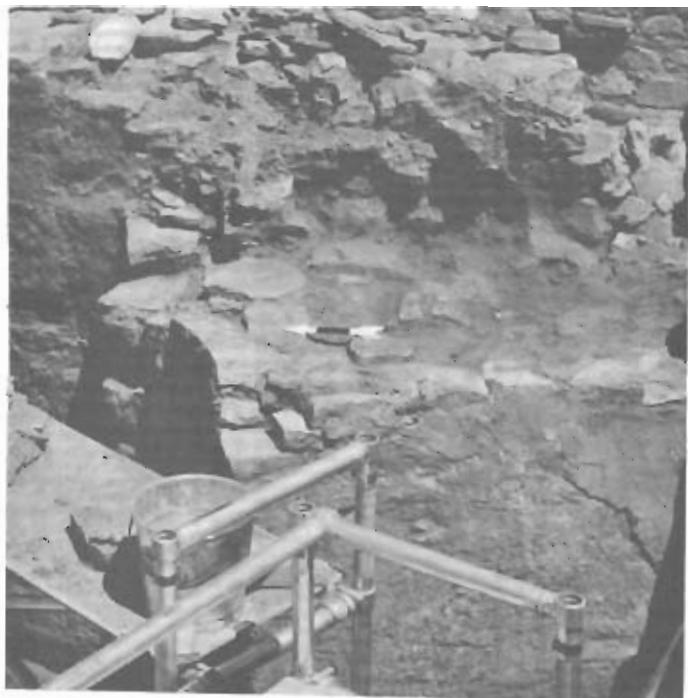
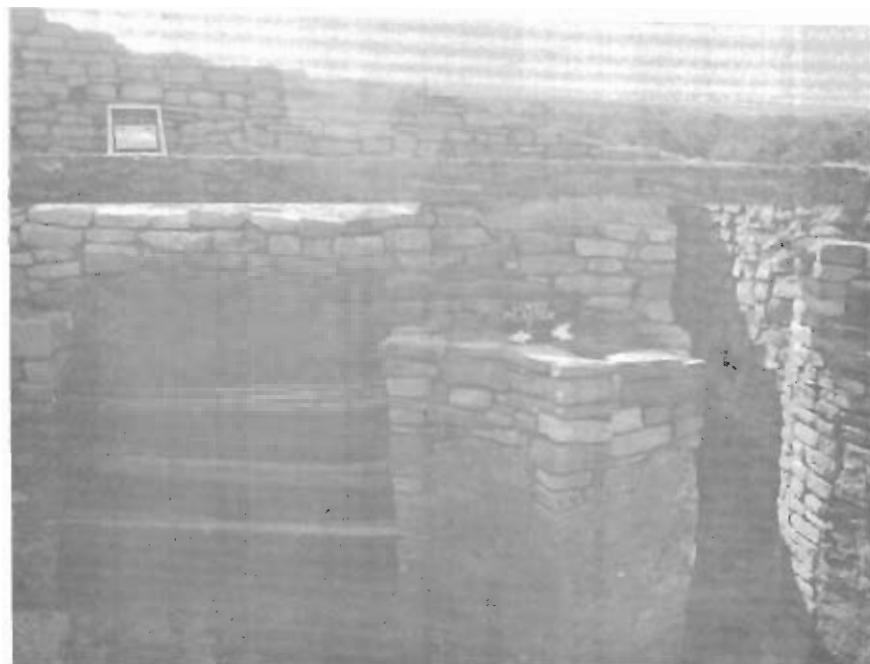
Figure 63. Kiva B, pilaster 7. a, before stabilization; b, after stabilization.

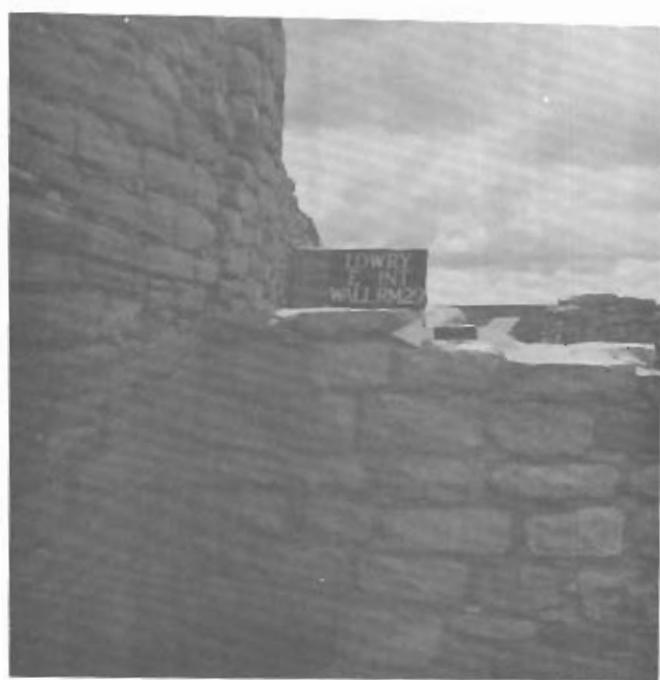
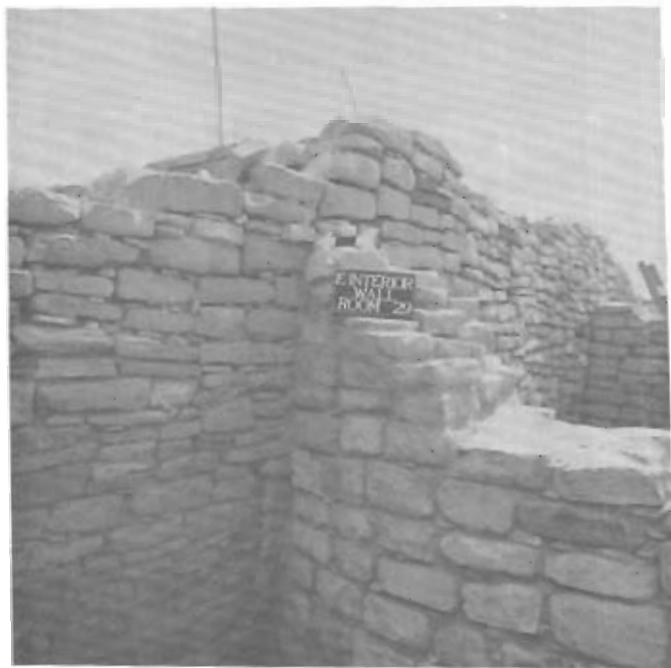
Figure 64. Room 29, east interior wall. a, view of wall before it was stepped up to brace the north wall; b, wall after courses were added.

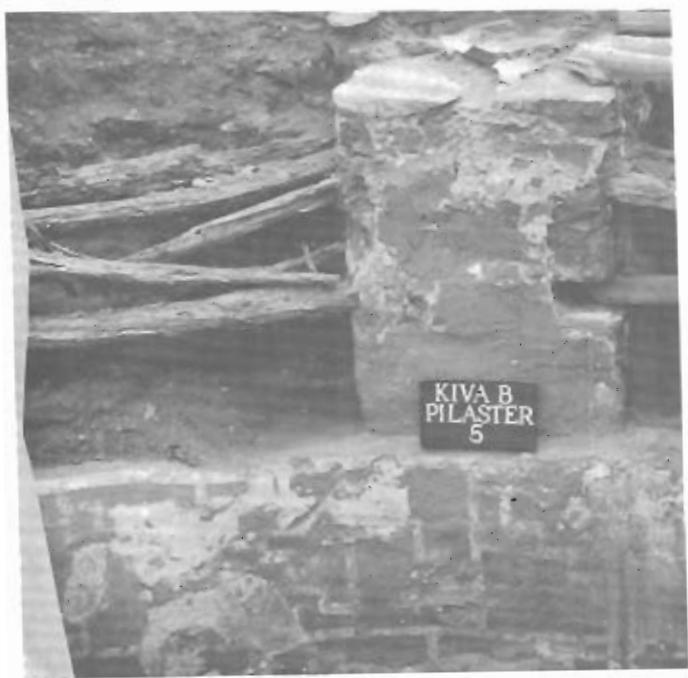
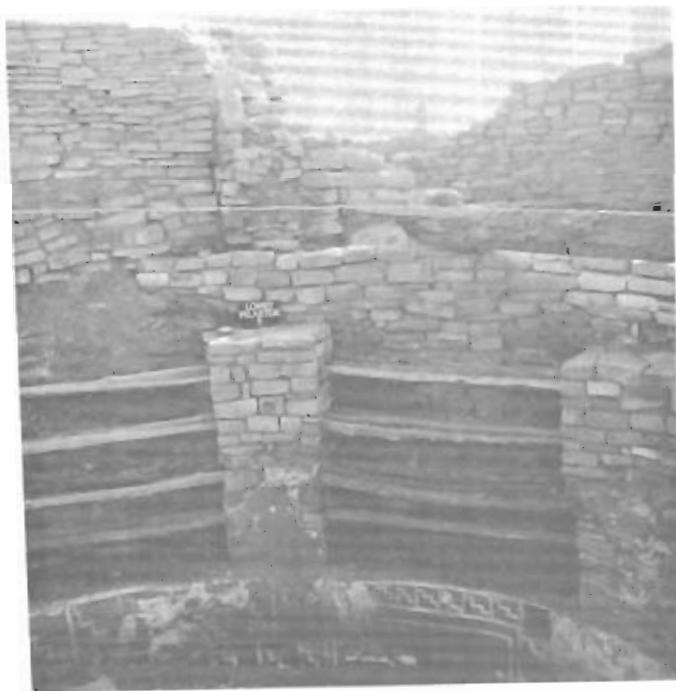
Figure 65. Kiva B, pilaster 5. a, pilaster before stabilization; b, about 66cm. was added to pilaster, also new shelves to either side of pilaster 5.

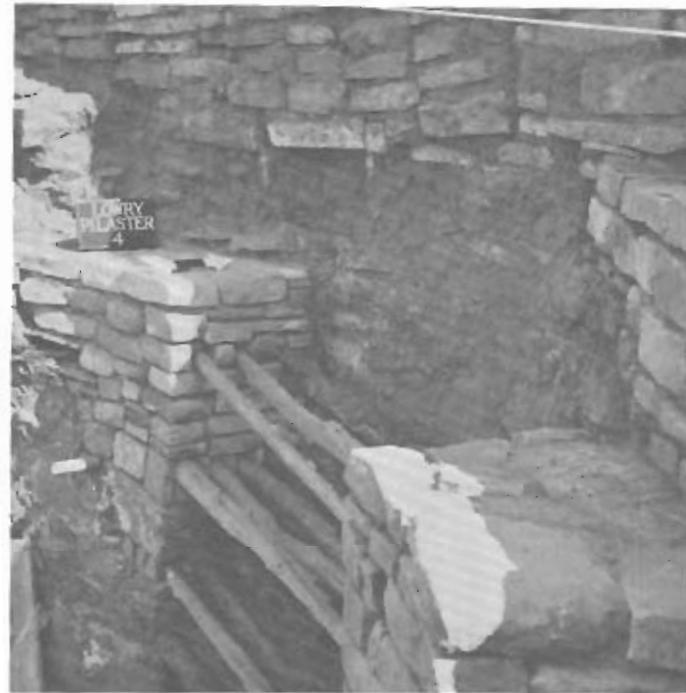
Figure 66. Kiva B, pilaster 4. Pilaster was stepped into the west wall of Kiva A. No photo was taken before stabilization.

Pilaster was reconstructed with reused stone from 48-88 cm. in height to original height. A cement mixture of Portland Type I and II cement and Shiprock sand. Joints were grouted to a depth of $\frac{1}{2}$ inch and pointed with a soil cement mixture of 4 parts sand to 1 part sand.

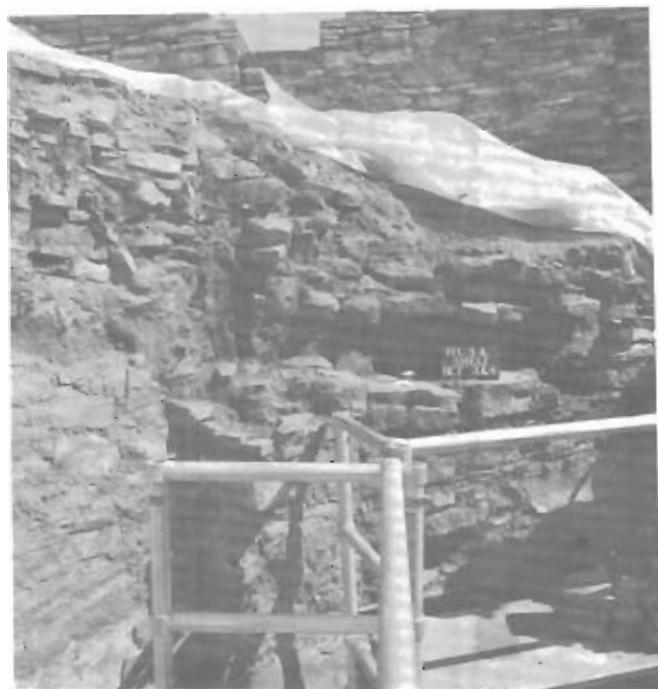
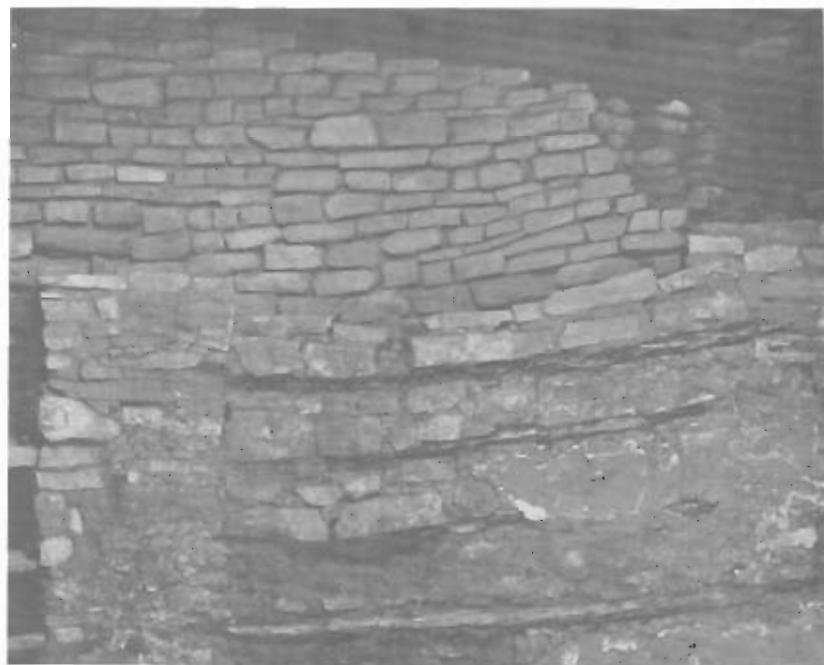
Figure 67. Kiva B, pilaster 3. a, before stabilization; b, after stabilization and painting of the joints.

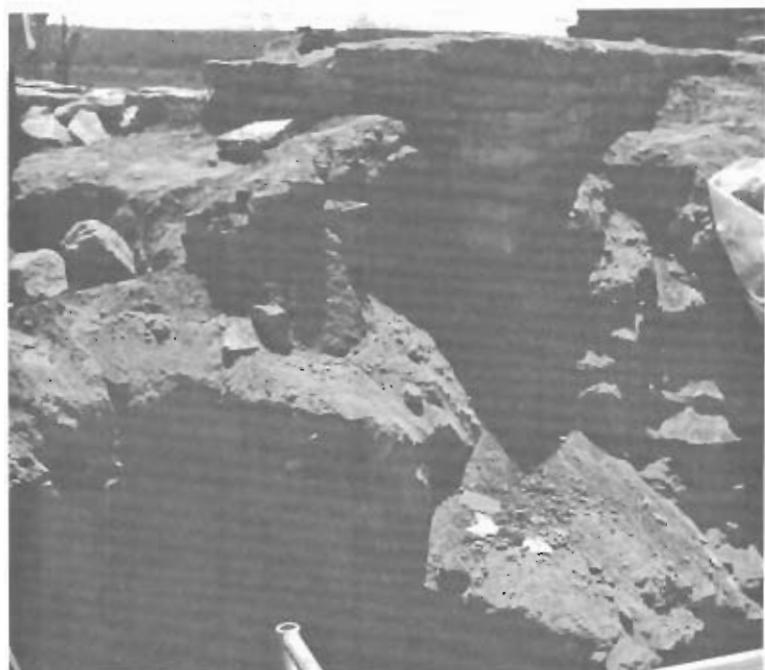
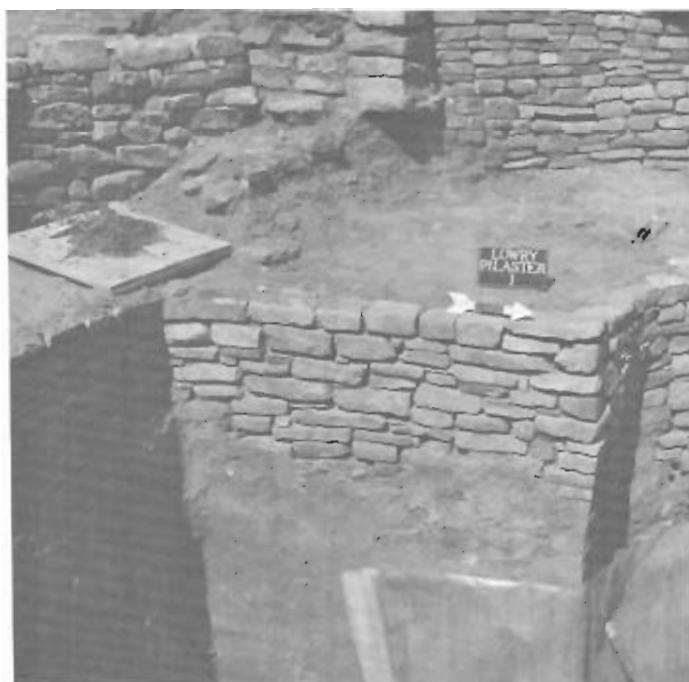
Figure 68. Kiva B, pilaster 1. a, before stabilization; b, after stabilization.

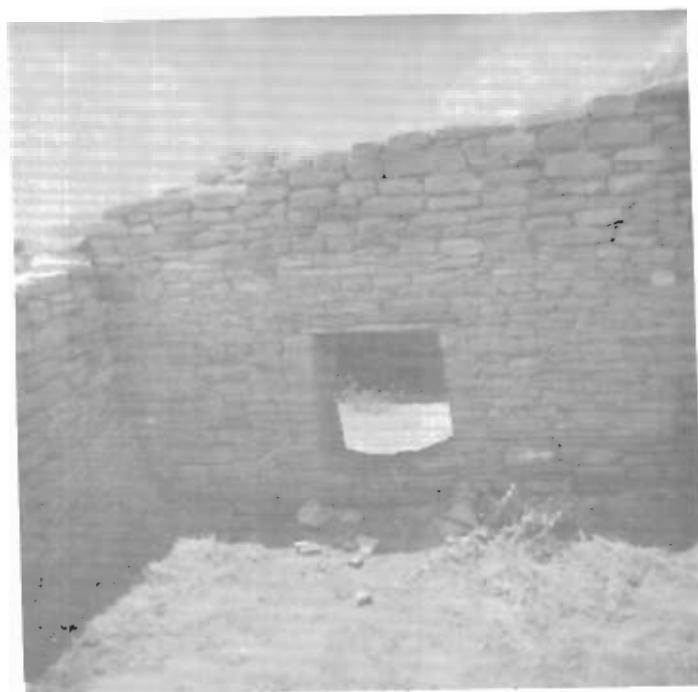
Figure 71. Room 27, east exterior entrance. a, entrance before stabilization in 1965; b, after stabilization in 1965 room was filled to above "T" of doorway.

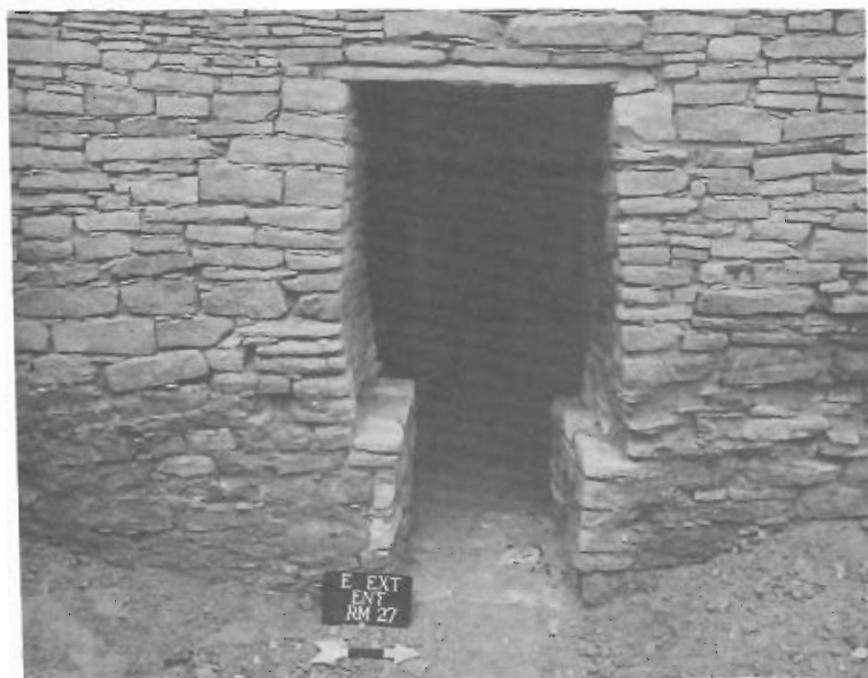
Figure 71. Room 27, east exterior entrance. c, after excavation and stabilization.

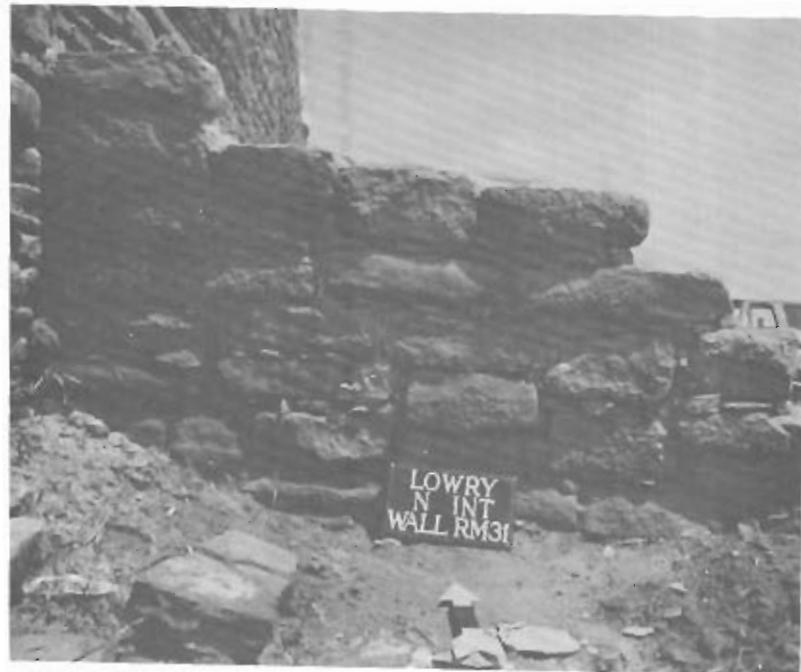
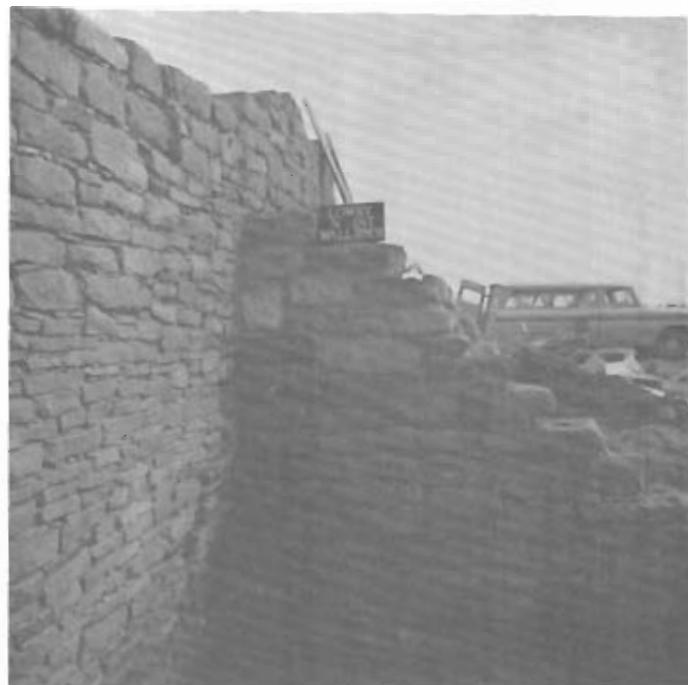
Figure 73. Room 31, north interior wall. a, before wall was stepped up as a brace to the west wall; b, after stabilization.
